**Purpose:** CERCLA Site Inspection

**Site:** Stauffer Chemical Company  
AKA: ICI Americas  
1415 S. 47th Street  
Richmond, California  
Contra Costa County

**Report Date:** July 14, 1994

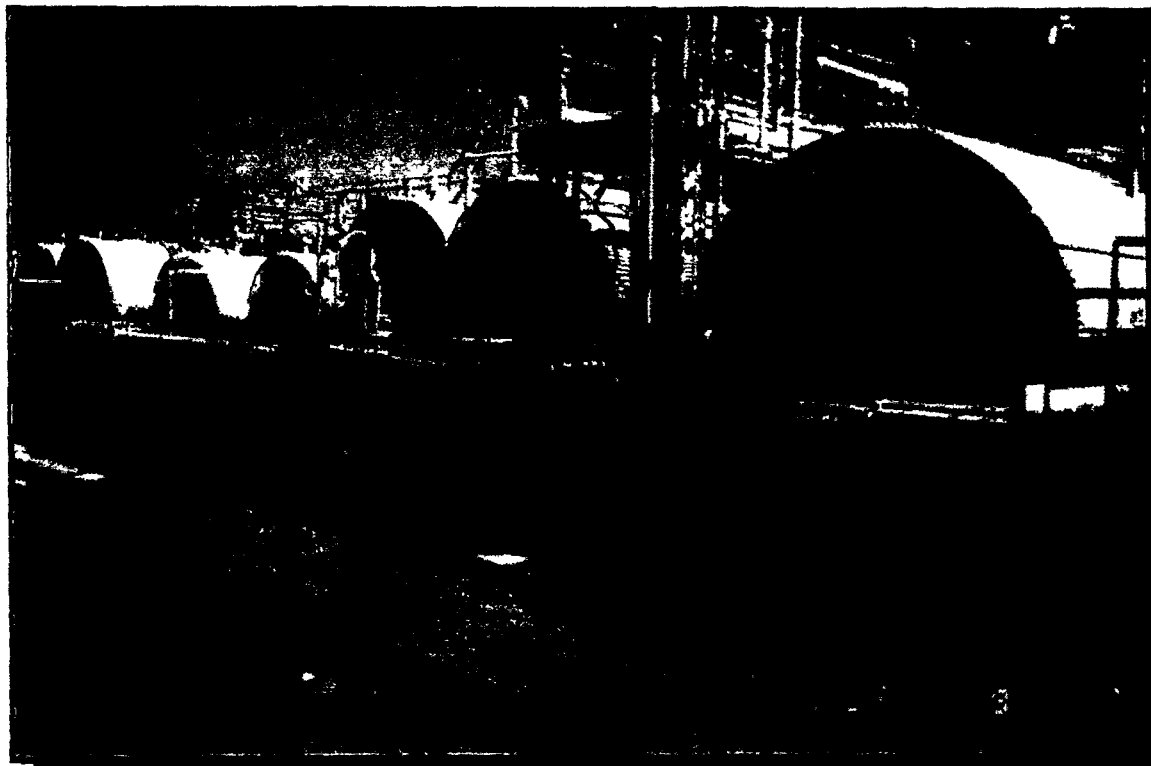
*Description:* Tank complex used in the batch processing of thiocarbamate pesticides Railroad spur is adjacent to tank complex

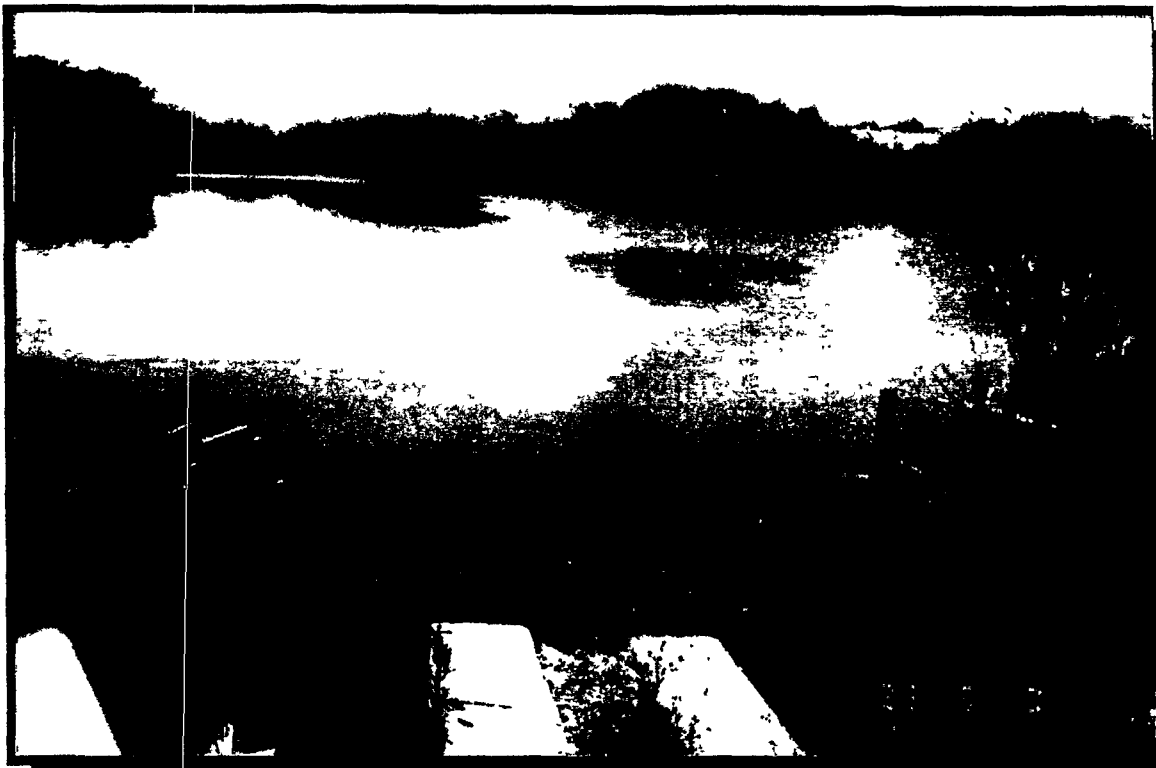
Photo No: 3  
Date: 6/9/92  
Time: 15:00  
Direction: West  
Weather: Clear  
Photo by: Zwierzycki

**Description:** View of evaporation pond 1. Note ICI Americas warehouse facilities in upper right-hand corner of picture. Photo was taken from between evaporation pond 1 and evaporation pond 2.

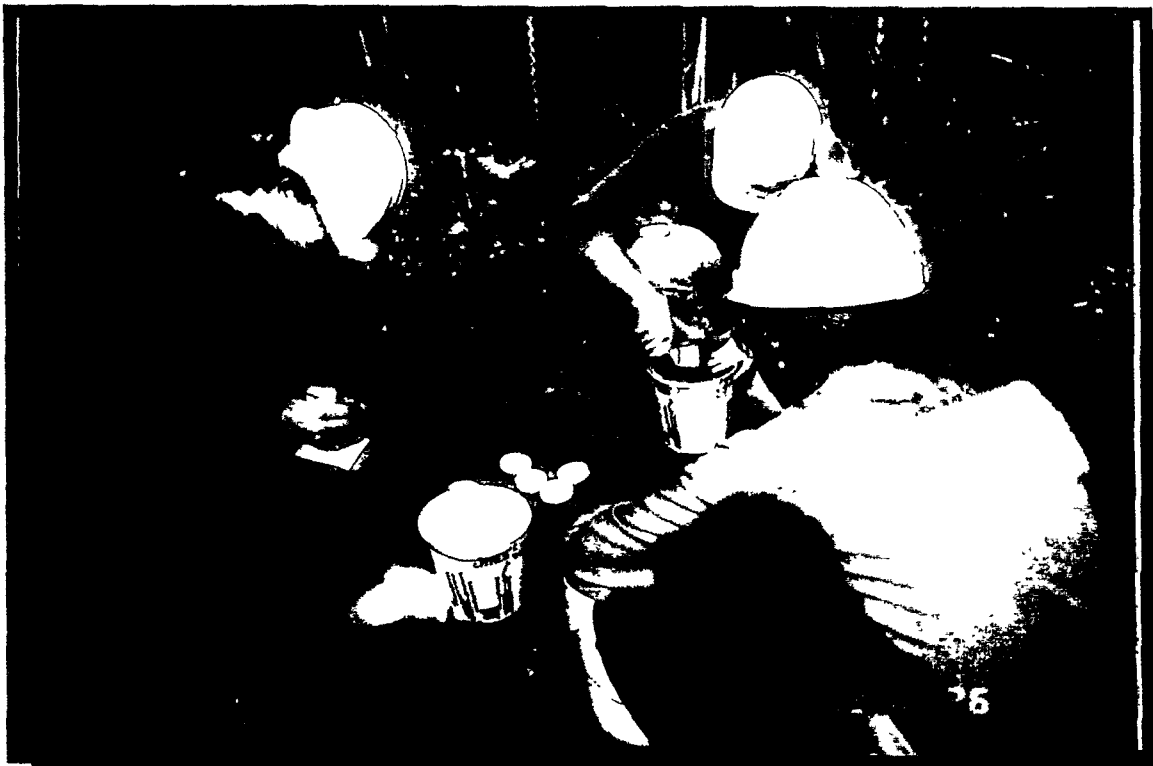
Photo No: 5  
Date: 10/26/92  
Time: 11:00  
Direction: Northeast  
Weather: Clear  
Photo by: Sam Won

Collection of soil sample S-1 and duplicate S-6 Fence in background is the western border of the Stauffer site. Note discoloration (purplish hue) to the soils The purplish soils correspond to the extent of the cinder landfill and were assumed to be cinder wastes.
